# **DIABLO CANYON AREA**

## **SEISMIC HAZARD OF THE GEOLOGICAL BEDROCK**

**A photo-documented geological circumnavigation of the terrestrial area around the Diablo Canyon Power Plant**

By Ralph Bishop

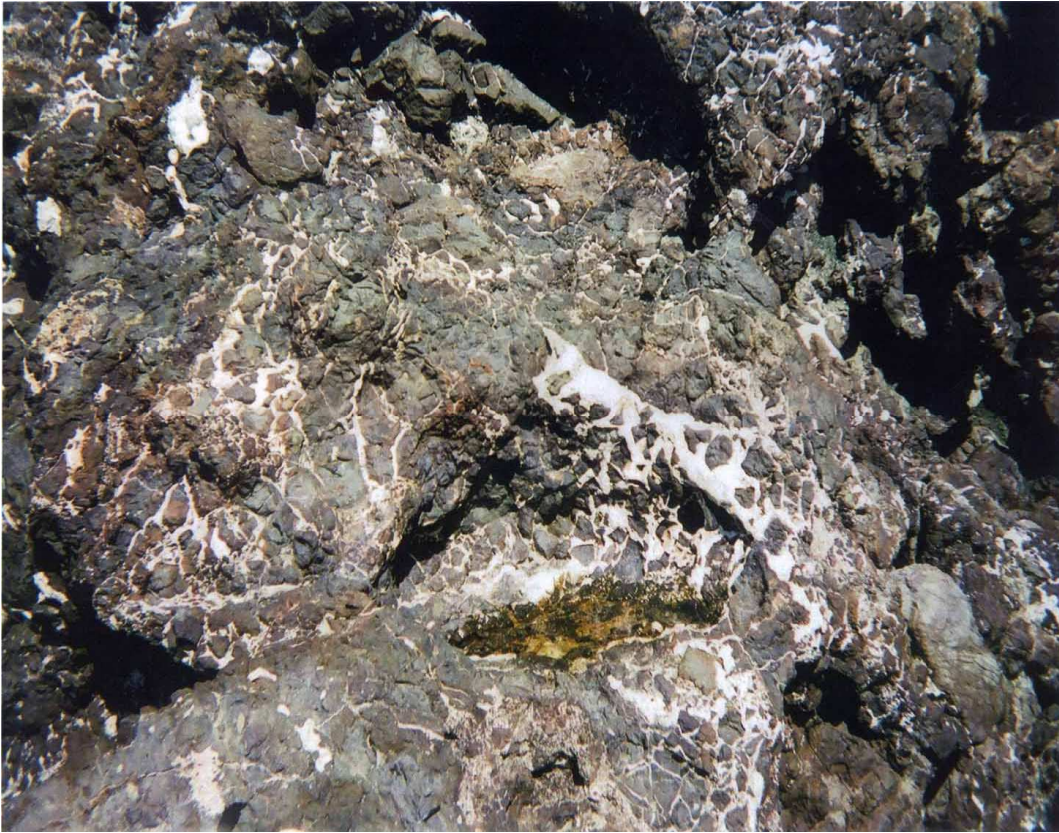
**Figure -4 Faulted zone in “Pillow Lava” formation showing resealed brecciation.**

At a number of places on this once solid formation, there are zones where tectonic forces have shattered the lava, opening up fissures that are now filled with Lavic Breccia. These fissures were then resealed with silica and calcite mineralization that was carried by deep-seated hydrothermal solutions (Figure –4).

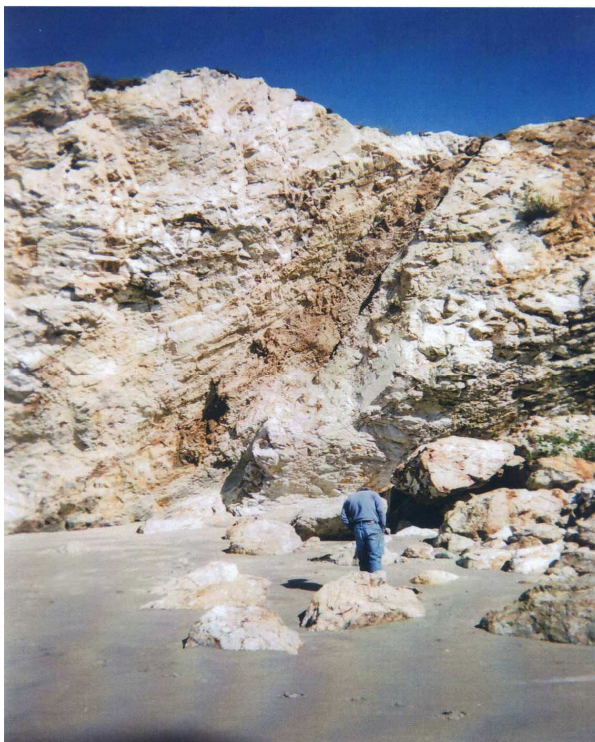
**Figure –6 Promontory sheared by a vertical line thrust fault from the main body of terrane. Location where brecciated rhyolite specimen was found.**

On the northern margin of this formation, one comes across two quite noticeable faults exposed on the sea cliff. The first is on the backside of a promontory that protrudes seaward (Figure –6). This textbook example of a vertical thrust is noticeably sheared from the rest of the terrane.

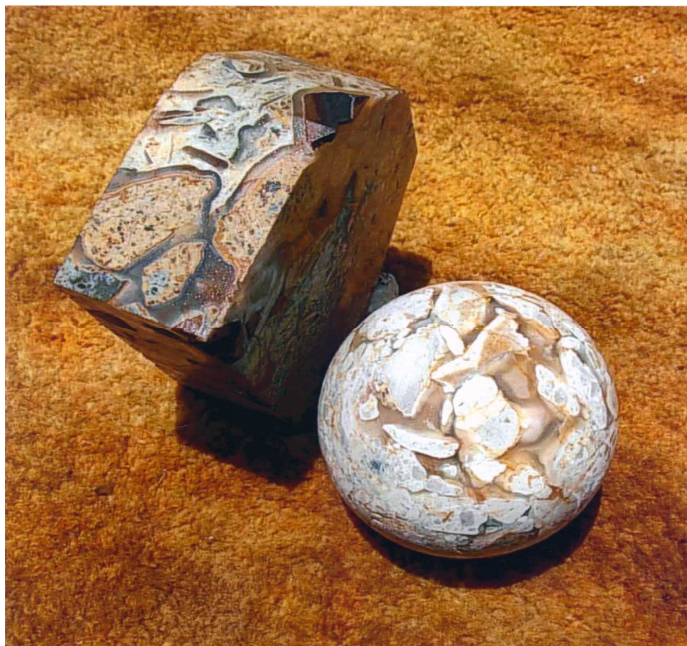
**Figure -7 Specimens of brecciated rhyolite resealed by silica (agate).**

At this location, specimens of brecciated rhyolite are found consolidated by silica in the same manner as the “pillow lava” formation (Figure –7). Certain specimens up to 2 feet wide are a positive indication that an earthquake event opened up a fissure at least that wide in a once stable rhyolite formation.

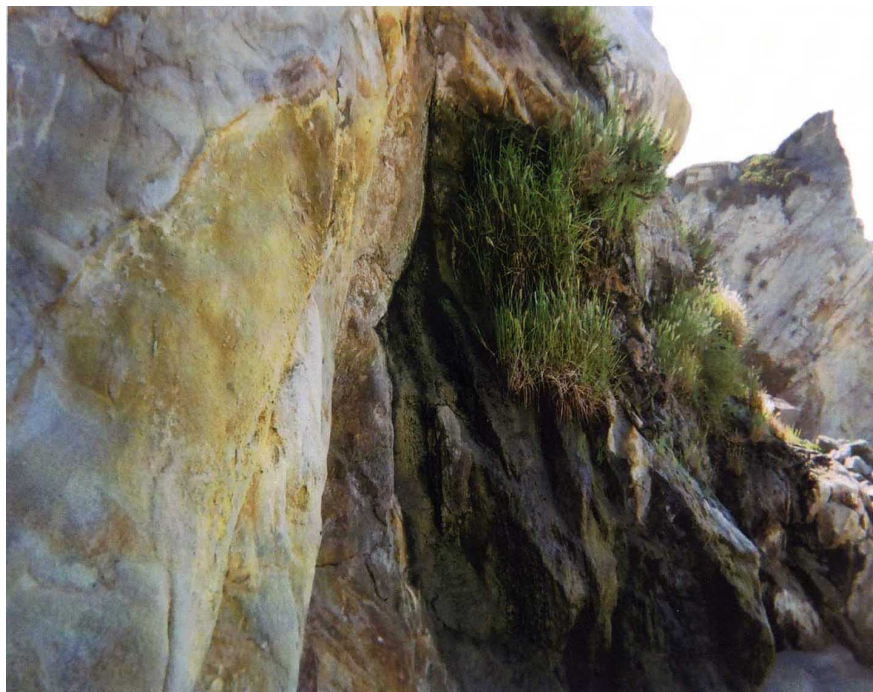
**Figure -8** Second fault exposure that runs at a right angle from promontory fault. Note yellow sulfur stain precipitated from mineral spring.

The second fault only 30 yards down the beach runs at a perpendicular angle to the first fault along the sea cliff (Figure –8).

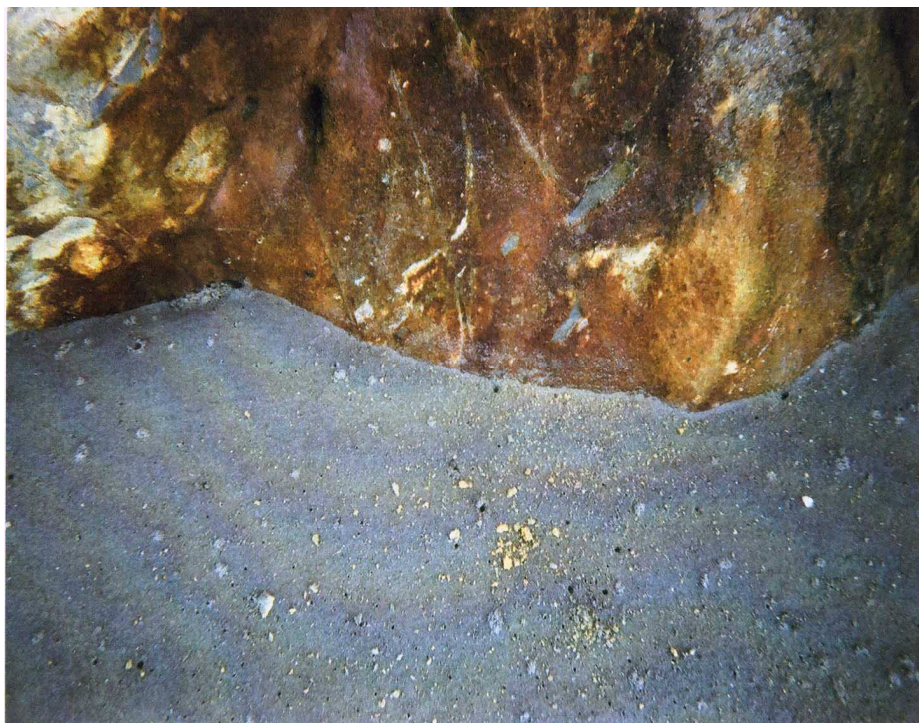
**Figure -9** Crumbles of sulfur below faulted spring face.

This fault strikes at 45° and actively weeps mineralized water, precipitating iron and sulfur that stain the rhyolite and constantly crumble onto the beach sand (Figure –9).

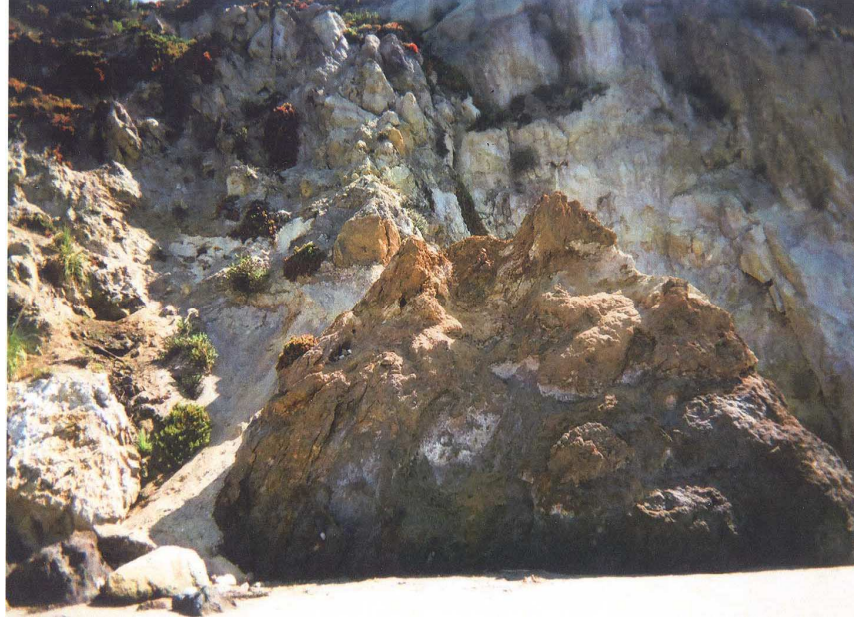
**Figure-10 Specimen of brecciated rhyolite discolored by hydrothermal mineralization.**

In close proximity to this hydro active fissure is a substantial remnant of crushed bedrock, the result of thrust faulting (Figure –10). Infusion of minerals carried by hydrothermal upwelling has discolored the brecciated mass. Natural weathering has created a textbook specimen of lithic brecciation.

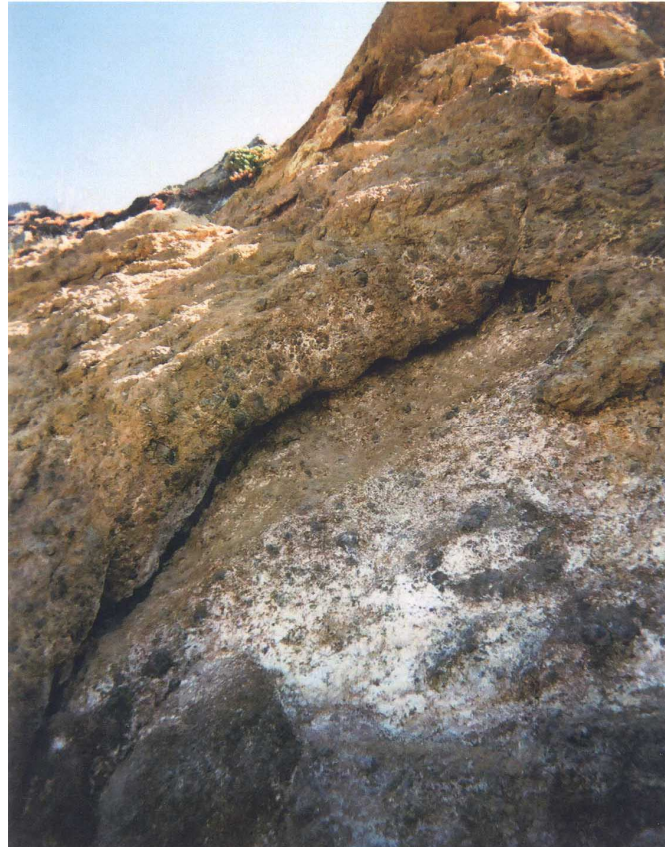
**Figure -11 Close-up of brecciated rhyolite specimen showing mineral leaching (oxidation).**

A close-up view of this mass exhibits large and small clasts (angular rocks) that compose this specimen (Figure –11).

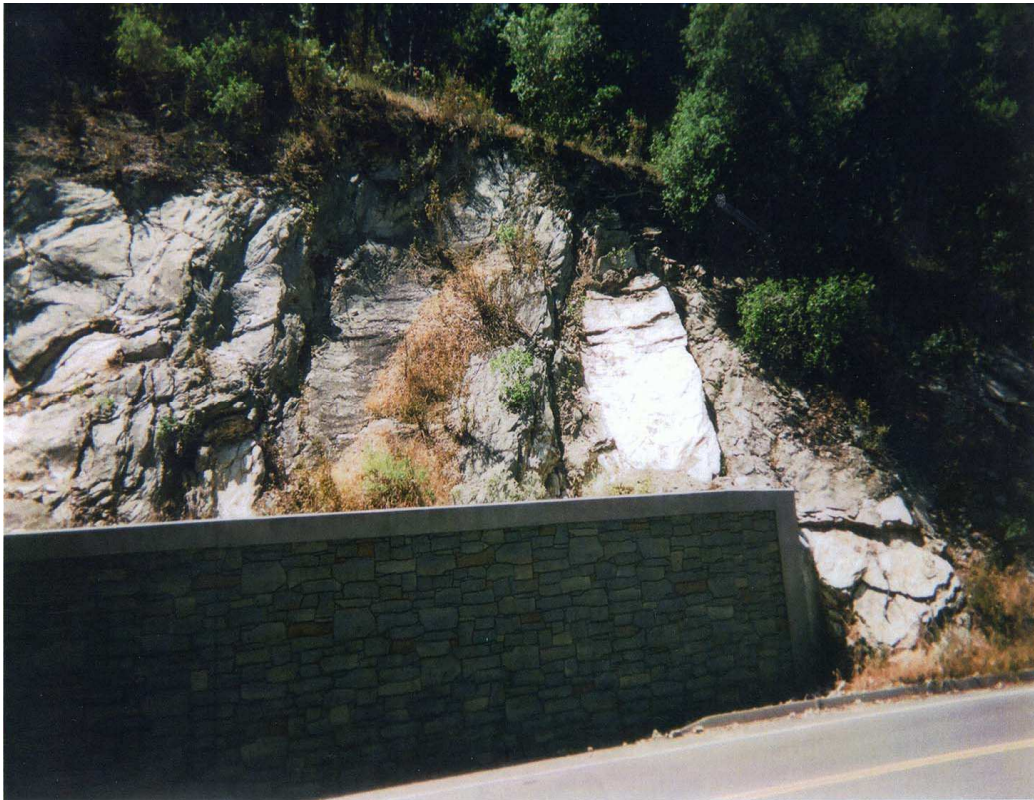
hand, allows one to see the radical uplift and tilting of the once horizontal bedding plane. Near the stop light on Avila Valley road, such an example is exposed in a road cut on the south side of the road (Fig #14). Here the shale is tilted at  $70^\circ$  facing north, while the same formation is nearly horizontal on the north side of the roadbed (Fig #15). Where would you suppose that fault lies?

**Figure -14** Monterey shale formation (approx. 12 million years old) radically tilted from its original horizontal plane, facing north.

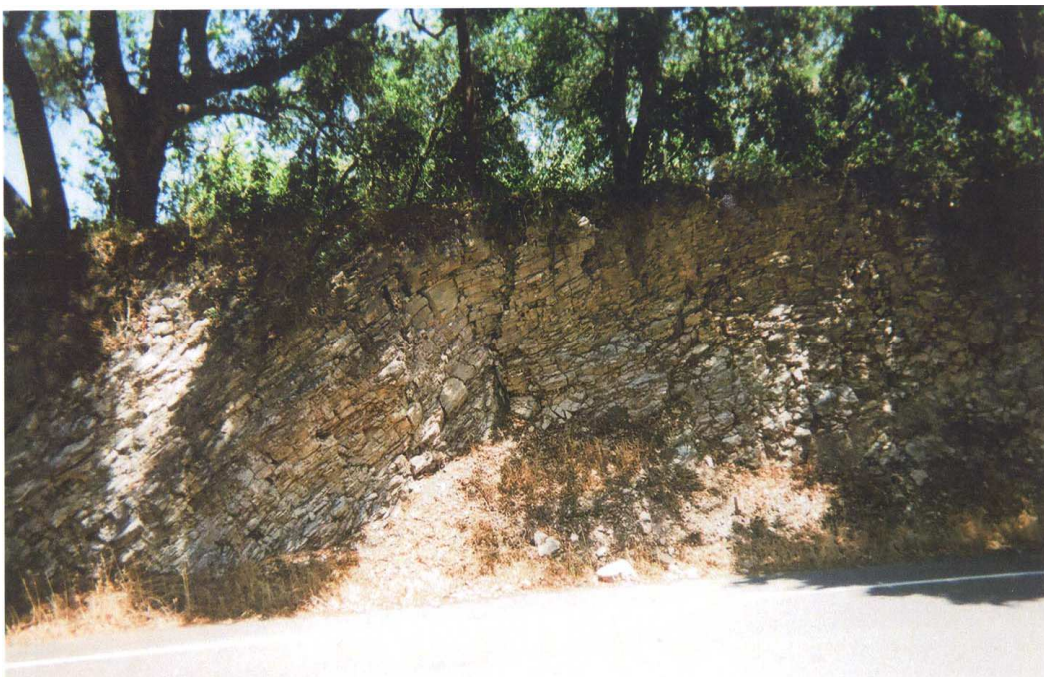
**Figure -15** Monterey shale formation in nearly horizontal position on the opposite side of Avila Valley road.

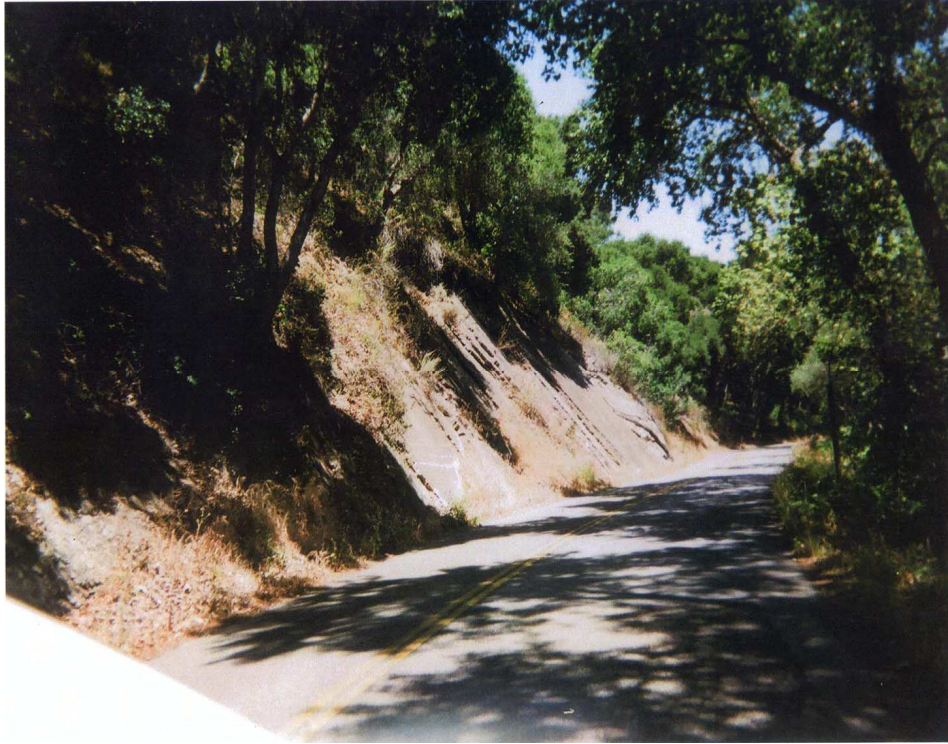
**Figure -16 Monterey shale formation on See Canyon road uplifted facing east.**

We will now travel north across Avila Valley and up See Canyon road about 1 mile. Here we find another road cut exposure of Monterey shale uplifted by a vertical thrust fault. This zone is related to the "pillow lava" terrane and is tilted at  $70^\circ$  facing east at a right angle to the same shale formation on Avila Valley road. This is a dramatic example of the geological wreckage and chaotic juxtaposition of one terrane with another (Figure – 16).

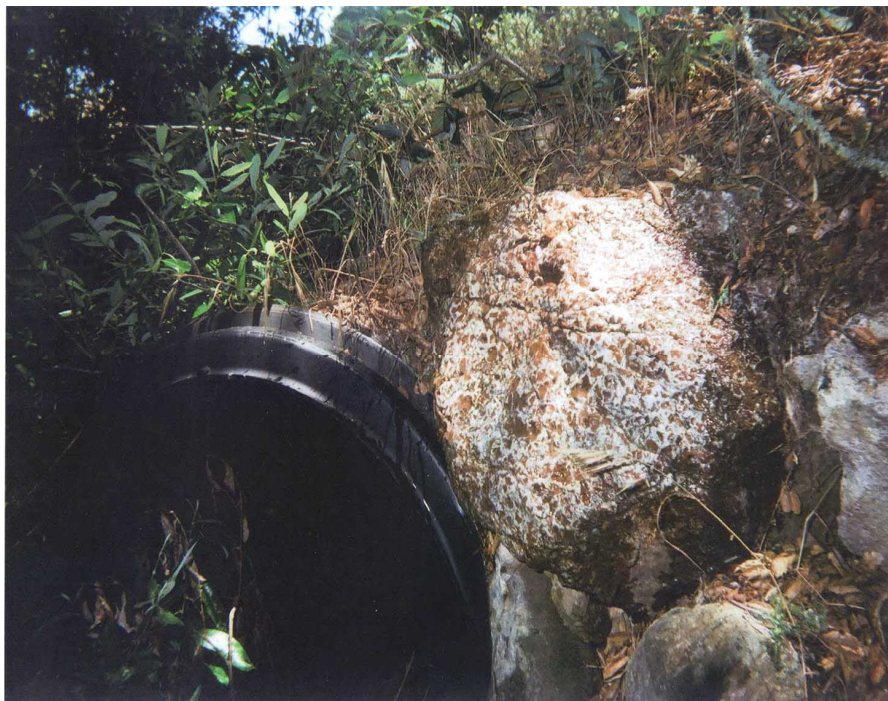
**Figure -19 Large specimen of brecciated Jasper found in creek showing that at least 1 seismic fissure in this zone was at least 3 feet wide.**

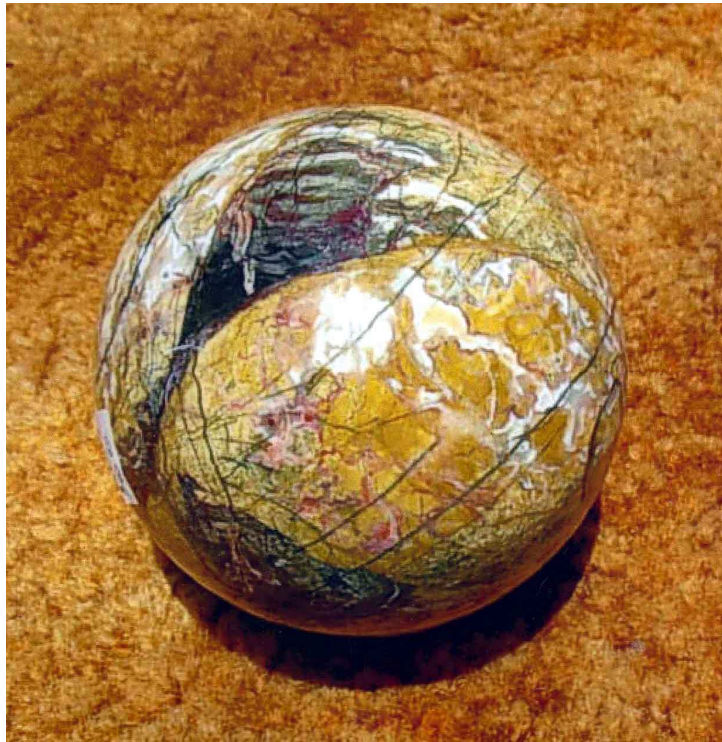
Jasper is formed as a solid infilling of open seismic fissures. During subsequent earth movements, this solid material is shattered and then resealed by mineralized hydrothermal solutions. Some specimens show multiple shattering events (Figure -20).

**Figure -20 Specimen of brecciated Jasper exhibiting multiple shattering events by earthquakes.**

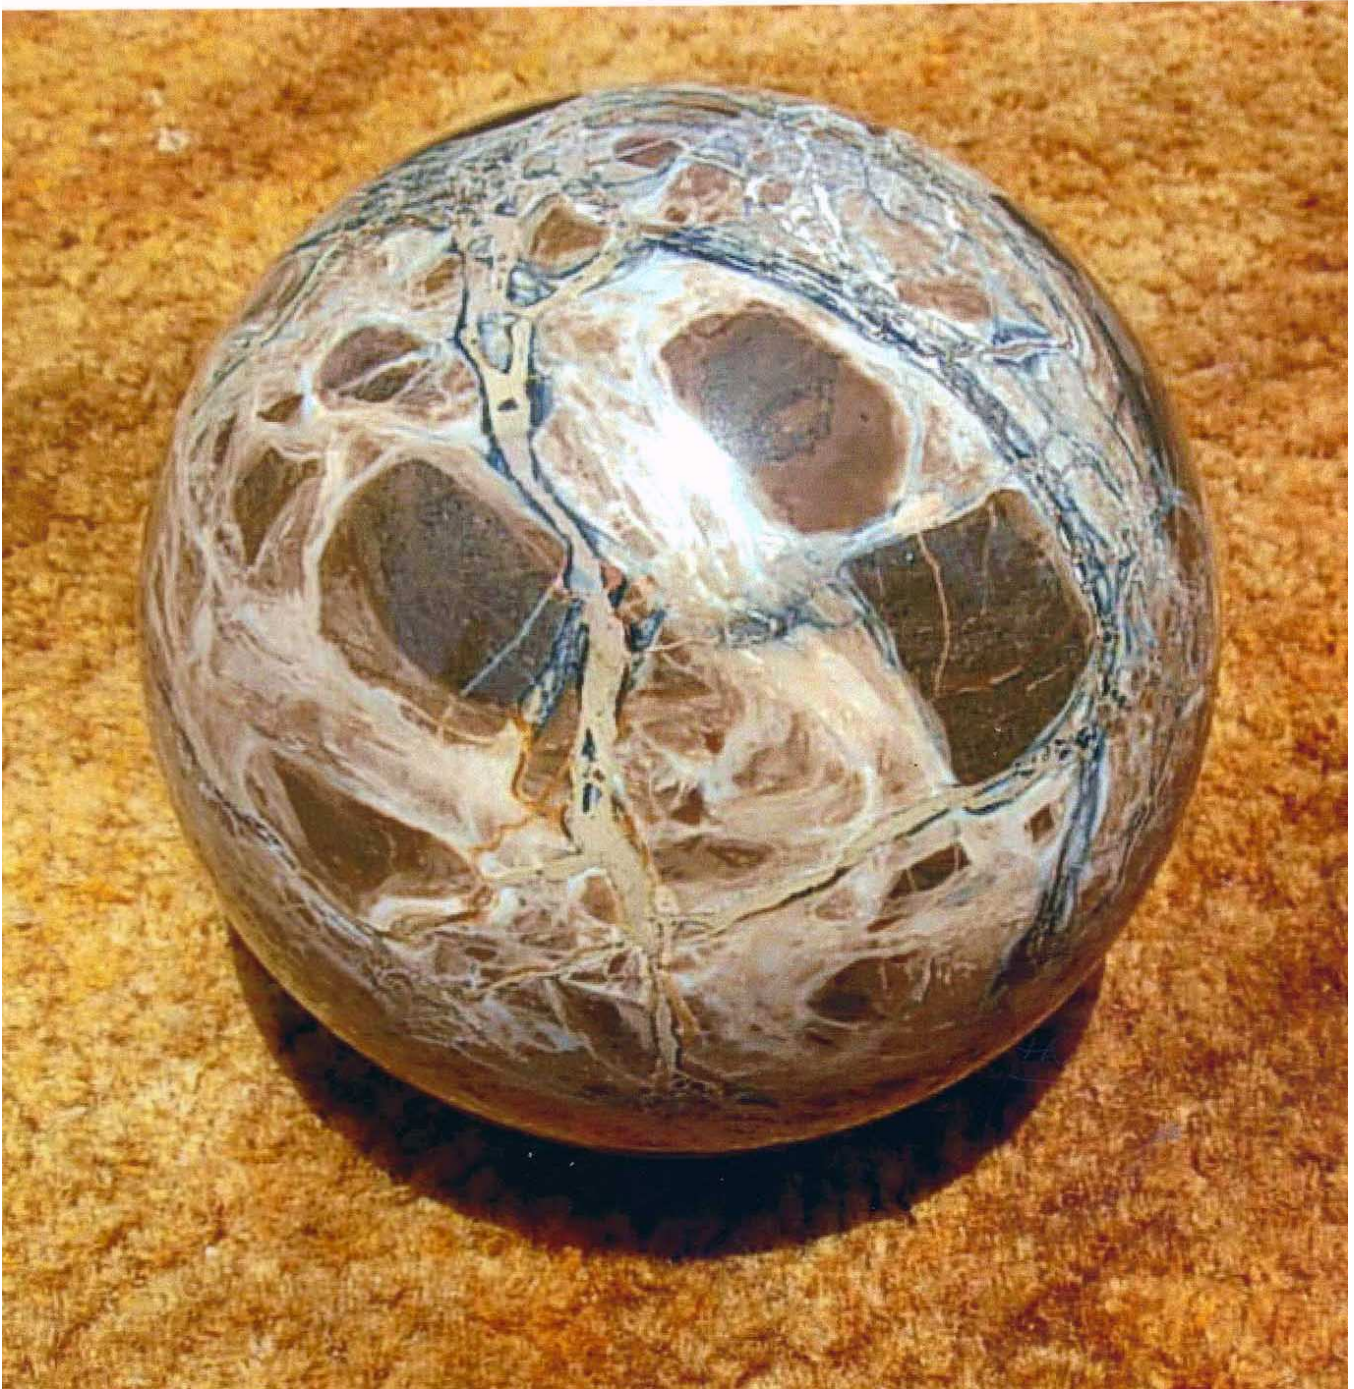
Found in this cove was a rock specimen of brecciated sedimentary rock infused and resealed by calcitic material showing at least two shattering events (Fig #30).

This is a positive indication that a fault runs through the center of the cove.

**Figure -30 Specimen of brecciated sedimentary material exhibiting at least two shattering events. Specimen found in cove at Montana De Oro.**
