# **DIABLO CANYON AREA**

## **SEISMIC HAZARD OF THE GEOLOGICAL BEDROCK**

**A photo-documented geological circumnavigation of the terrestrial area around the Diablo Canyon Power Plant**

By Ralph Bishop

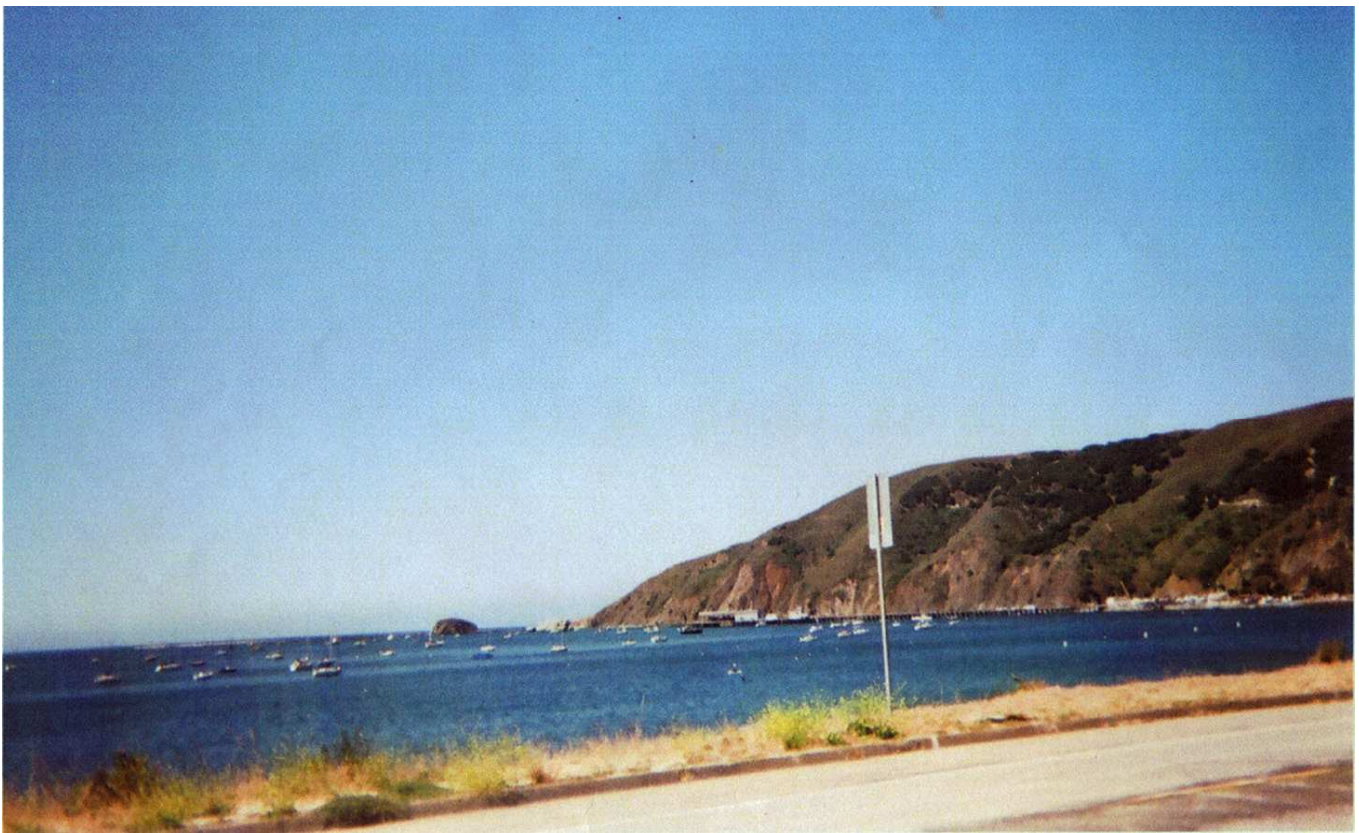
Figure - 1. North side of Avila Bay showing a headland terrane composed of "Pillow Lava" (approx. 90 million years old)

We will begin our tour on the north side of the Avila embayment just over a rocky hill from the Diablo facility; a headland terrane juts from the ocean waves (Figure -1). This headland is composed of a formation of "Pillow Lava", the finest example of its kind I have ever seen.

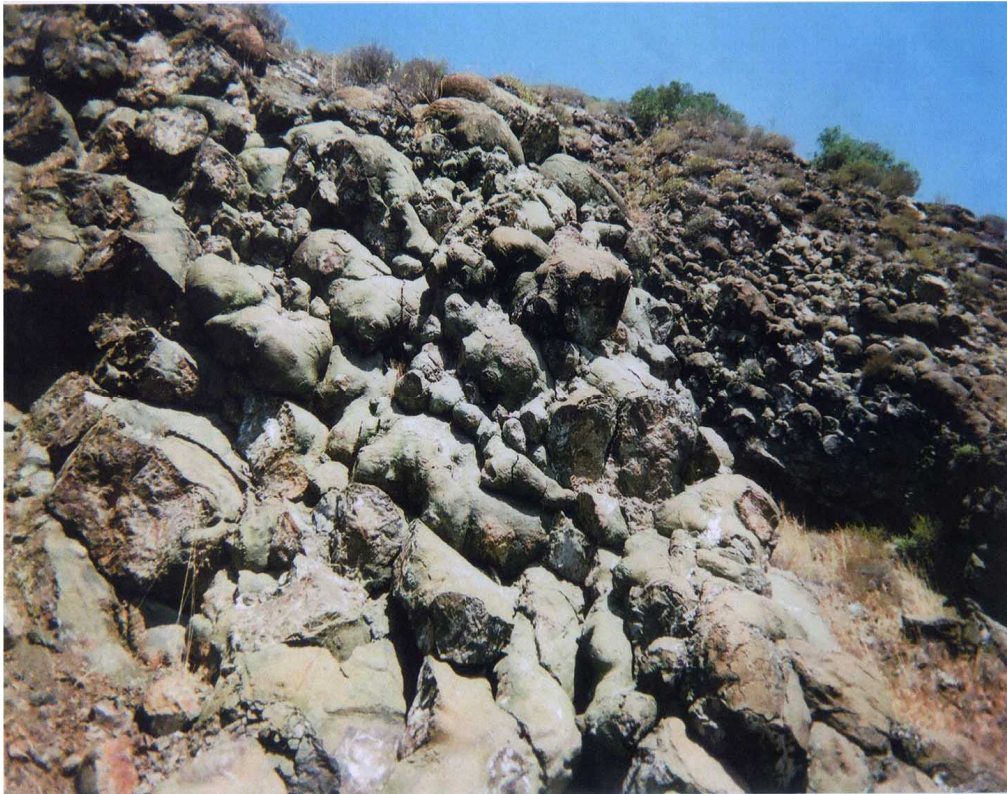
**Figure - 2. Sea Cliff exposure of “Pillow Lava”**

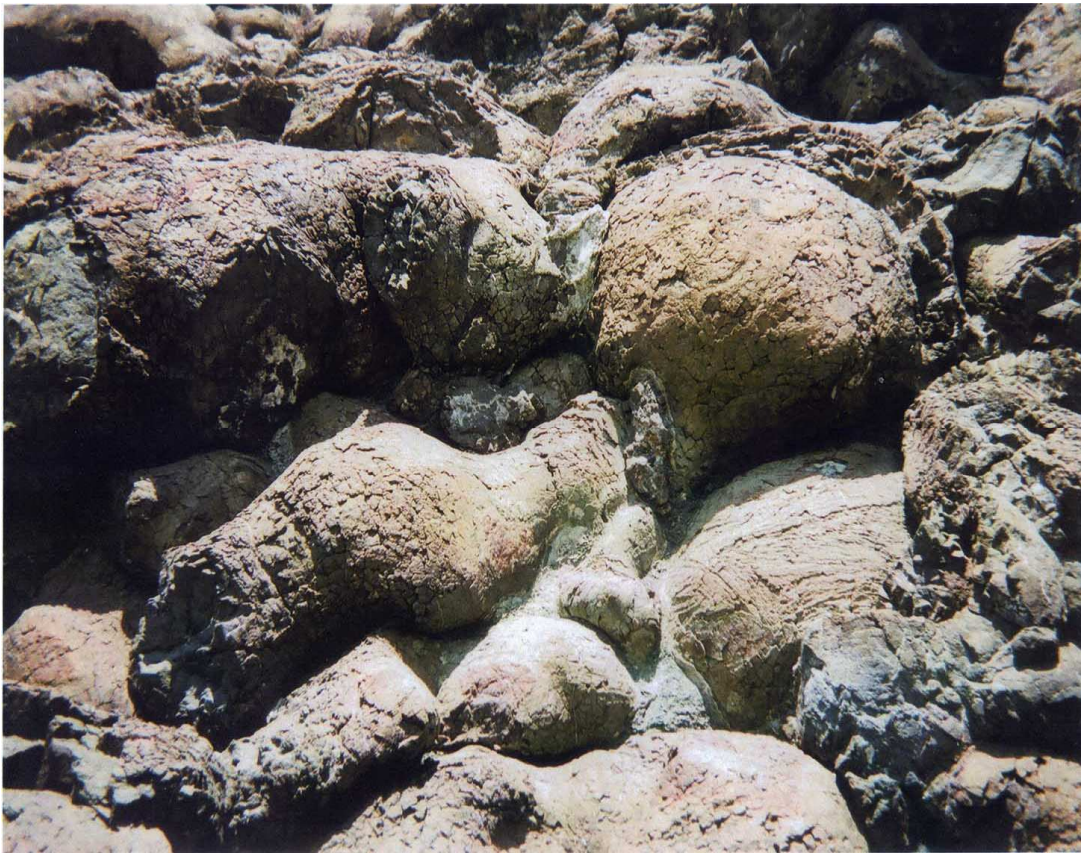
**Figure -3 Close-up showing the dynamics of an elongated “pillow” that has burst from a more bulbous “pillow.”**

A closer view (Figure -3) exhibits in exquisite detail a submarine lava extrusion frozen in time. The same process is happening on the Hawaiian Islands today.

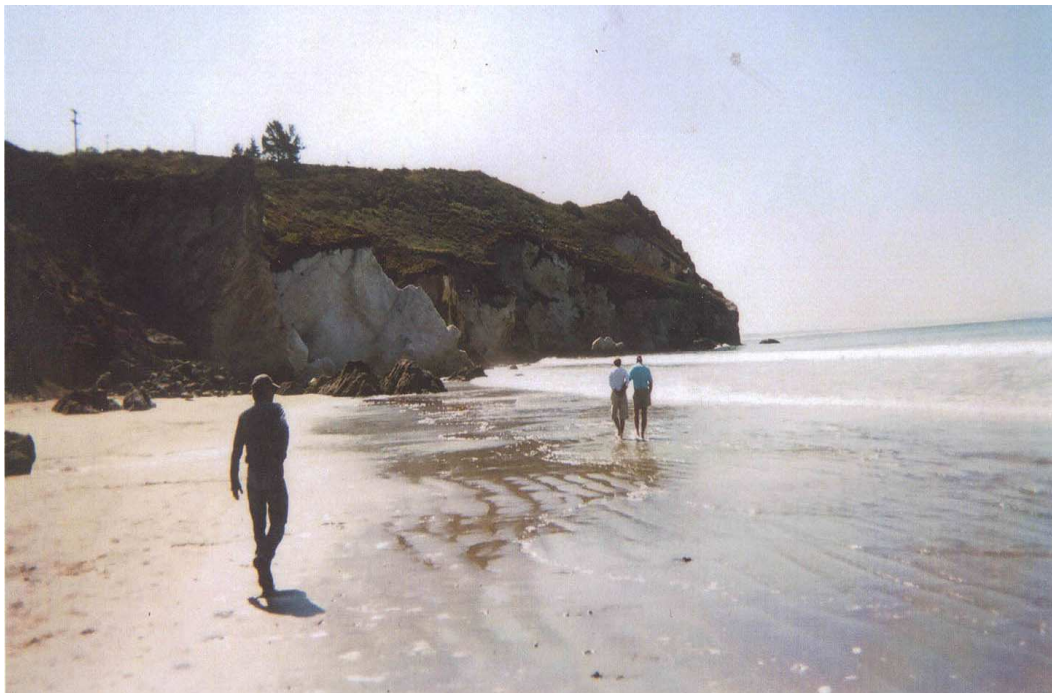
**Figure -5 South side of Avila Bay showing a headland terrane of rhyolite (approx. 25 million years old).**

We now travel to the south side of Avila Bay. Here we encounter another headland terrane composed of 25 million-year-old rhyolite, as dissimilar in make up as it is in age from the “pillow lava” rising vertically from the sea (Figure –5).

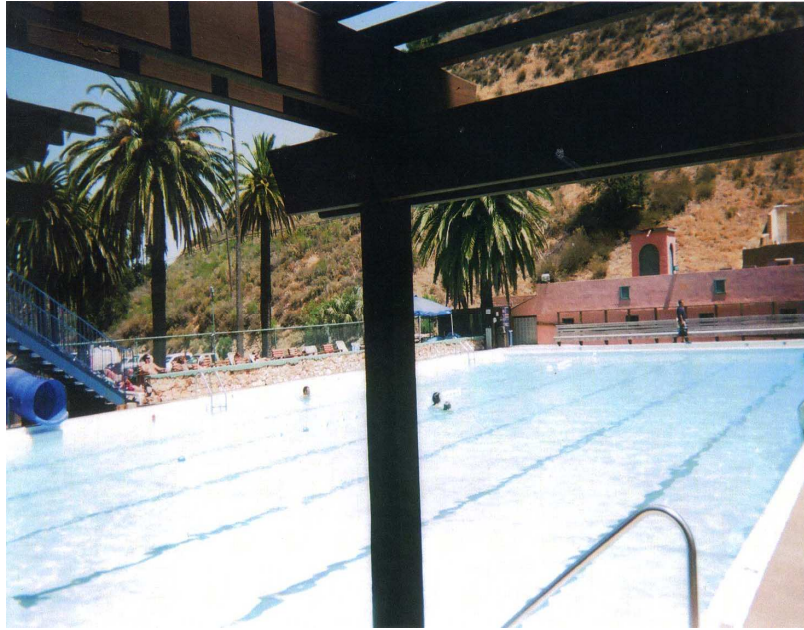
Figure -12 Avila Hot Springs Resort

We will next travel up Avila Valley to the east. The Avila Valley transects the two major terranes we have already visited. The Avila Valley marks the northern boundary of the rhyolite terrane, where it is overlain by 12-million-year-old Monterey shale formation. The road to Avila follows this faulted margin, passing two large commercial hot spring resorts. The first is Avila Hot Springs, whose hydrothermal was has a defined stench of sulfur (Figure –12). The second is Sycamore Mineral Springs (Figure –13).

These two significantly active deep-seated hydrothermal springs are a positive indication that there is an open faulted conduit beneath the surface. It is often difficult to group the chaotic angles that are created by vertical thrust faults by viewing unstratified formations like the "pillow lava" and rhyolite. The Monterey shale formation, on the other

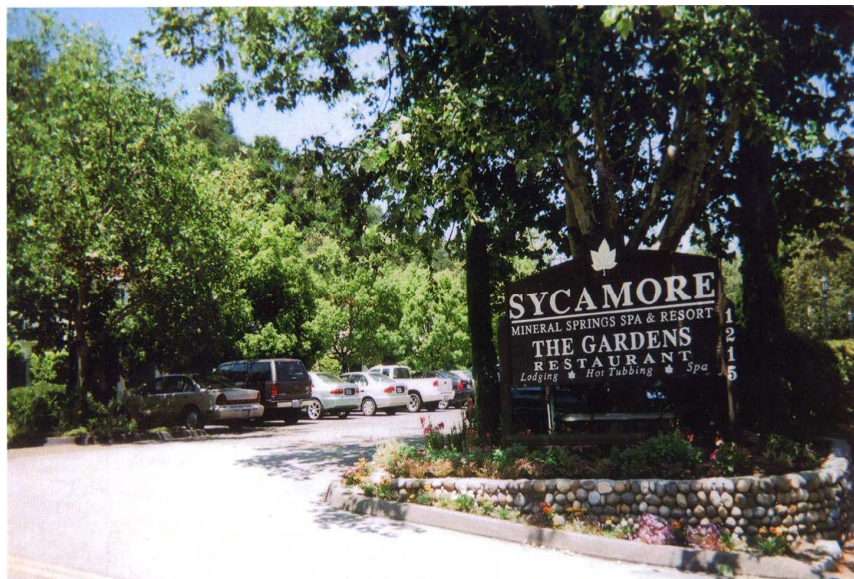
Figure -13 Sycamore Hot Springs Resort

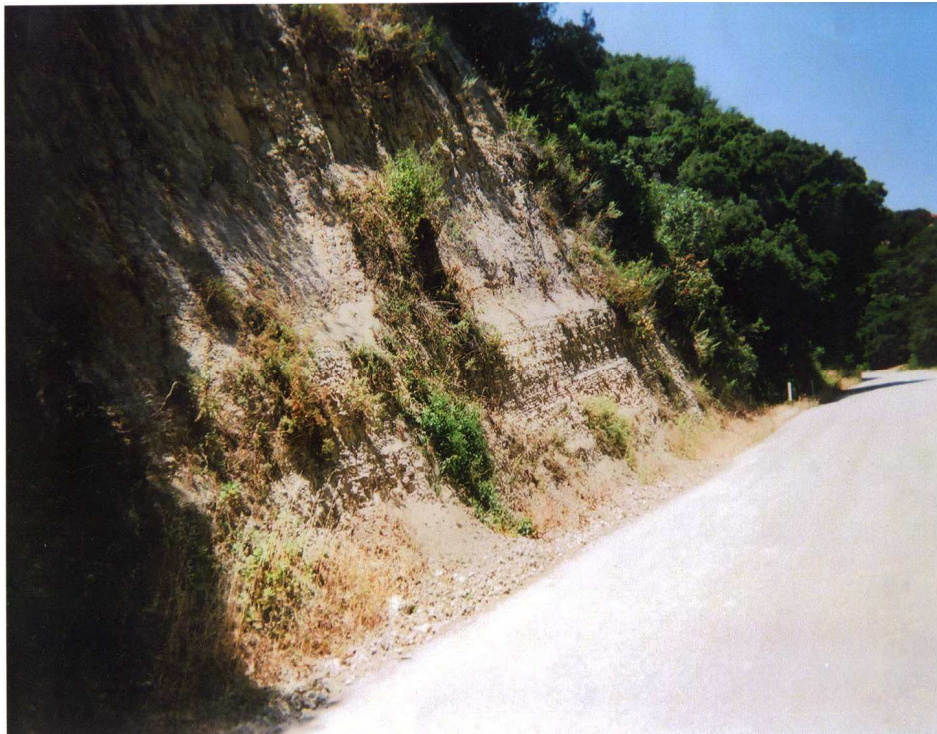
**Figure -17 Monterey shale formation near See/Perfumo Canyon saddle in nearly horizontal position.**

Farther up See Canyon road. Nearing the saddle between See and Perfumo Canyons, another road cut exposure shows the shale strata again nearly horizontal (Fig 17). Over the breadth of the saddle, geological exposures turn from shale to sandstone and into serpentine. Although I have not pinpointed the fault scarps in this area, ample evidence can be found on the hillsides and creeks. Here we find specimens of brecciated jasper with dissimilar colored Jasper and mineralized infilling (Figures -18. -19, -20).

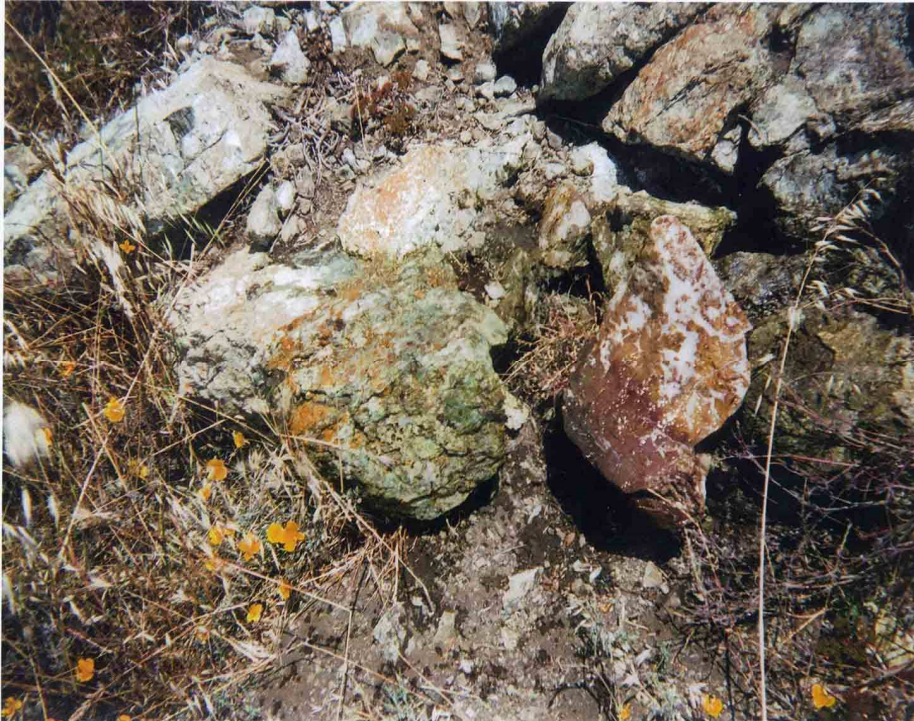
**Figure -18 Brecciated Jasper found on hillside of serpentine near sandstone interface.**

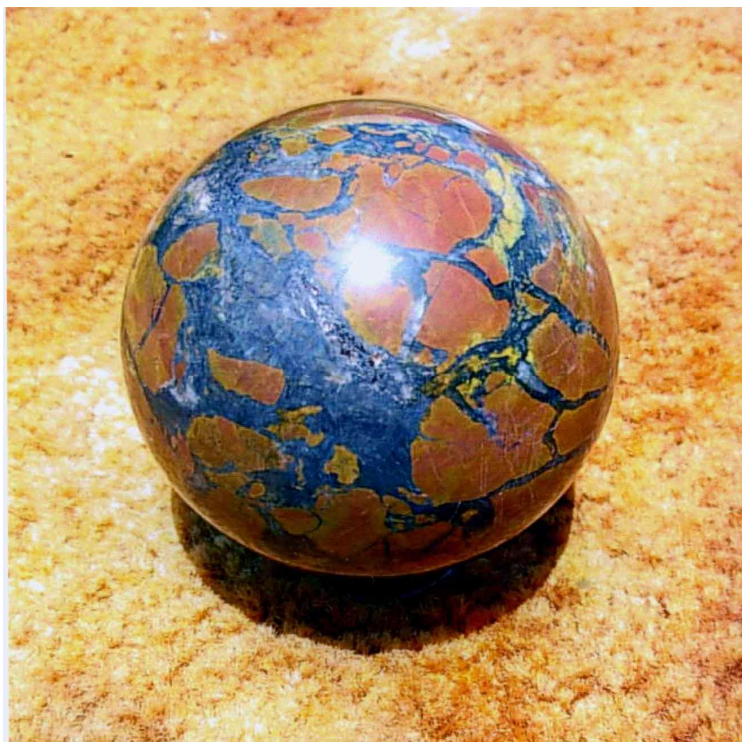
**Figure -21 Specimen of brecciated Jasper showing dissimilar coloration of Jasper and silica/manganese infilling.**

Because of the many colors of both the jasper and resealed, I believe there are a number of faults at the interface between the serpentine and sandstone formations.

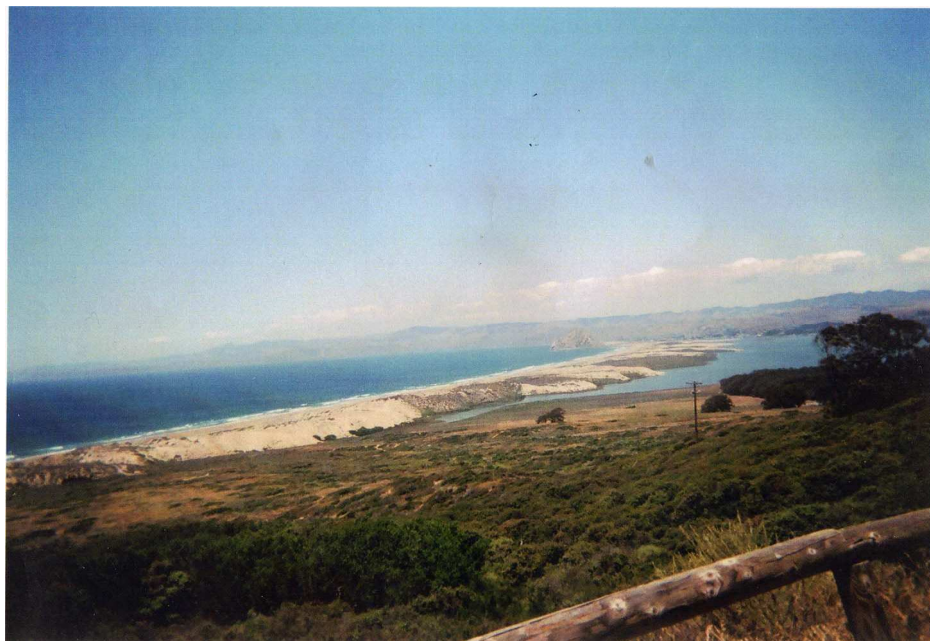
**Figure -22 Looking across Morro Bay with Cayucos at the base of horizon. Morro Rock (right of center) is composed of very dissimilar granite material.**

From this saddle we travel down Perfumo Canyon to Los Osos Valley and then to Montana De Oro State Park, due north of the Diablo facility. From a high vantage point, we can look across Morro Bay to the foothill horizon of Cayucos (Figure -22). This is where the recent 6.0 earthquake occurred. I have included photos of brecciated jasper from that area to drive home the point that the same tectonic and depositional process occurs in both areas (Figures -23, -24, -25).

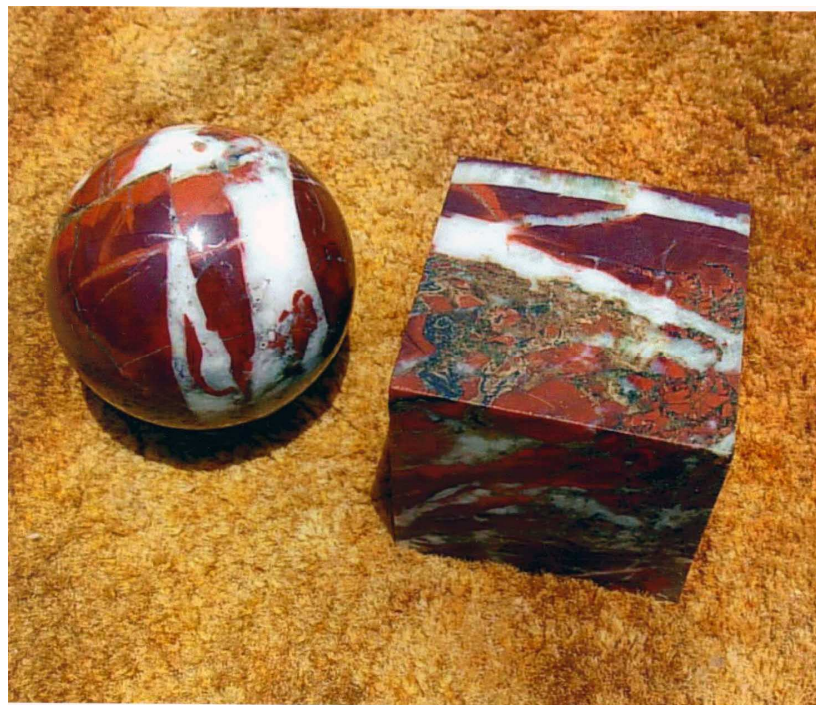
**Figure -23 Specimens of brecciated Jasper showing offsetting of “miniature terranes”. Whether small or miles wide tectonic forces create the same effect.**

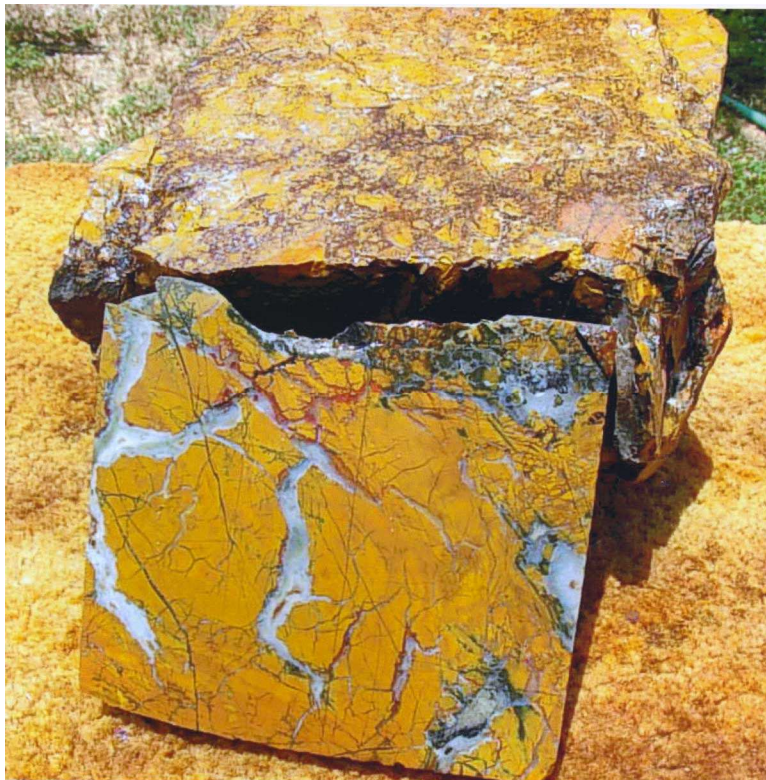
**Figure -24** Rough and cut specimens of brecciated Jasper. A macro view of the central coasts geological wreckage would be similar.

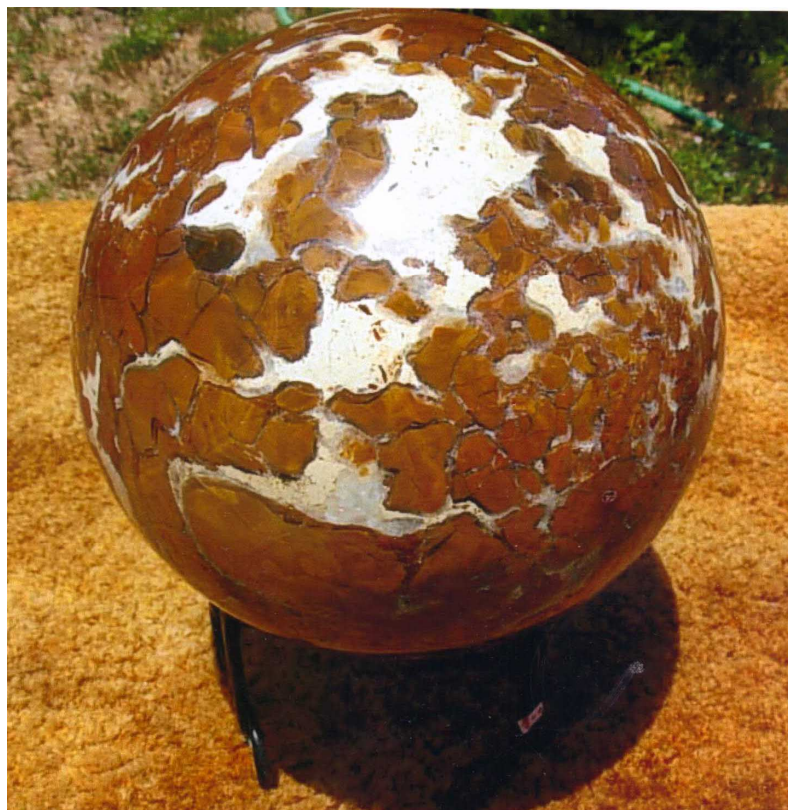
**Figure -25** Brecciated Jasper showing dissimilarity of mineralized Jasper denoting multiple faults.

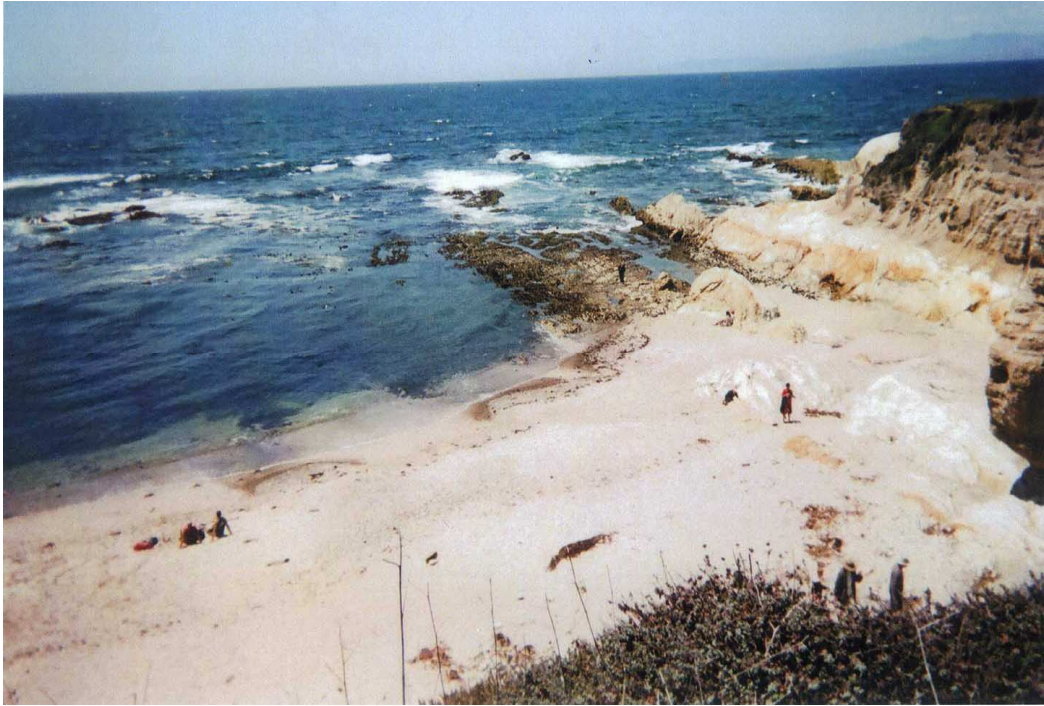
mile, we come to a small cove where the shale on the north side is tilted facing south (Figure -26,-27 and -28).

**Figure -26 North side of cove at Montana De Oro showing tilted sedimentary strata facing south.**

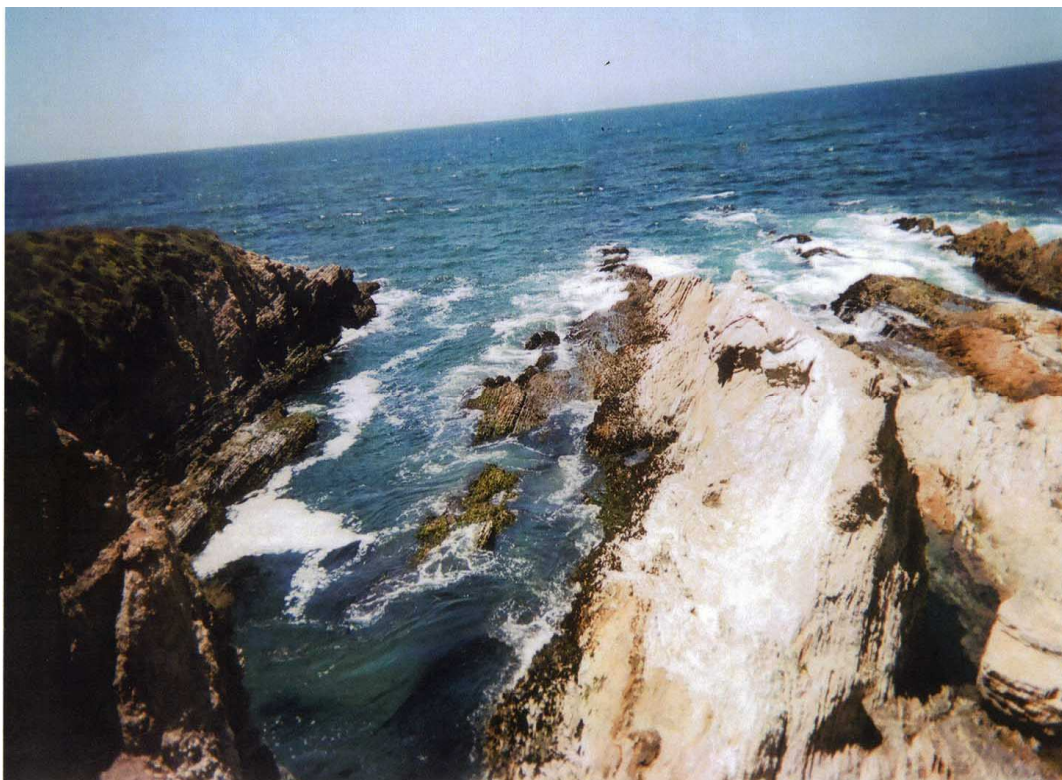
**Figure -27 Closer view of nearly vertical shale strata north of cove.**

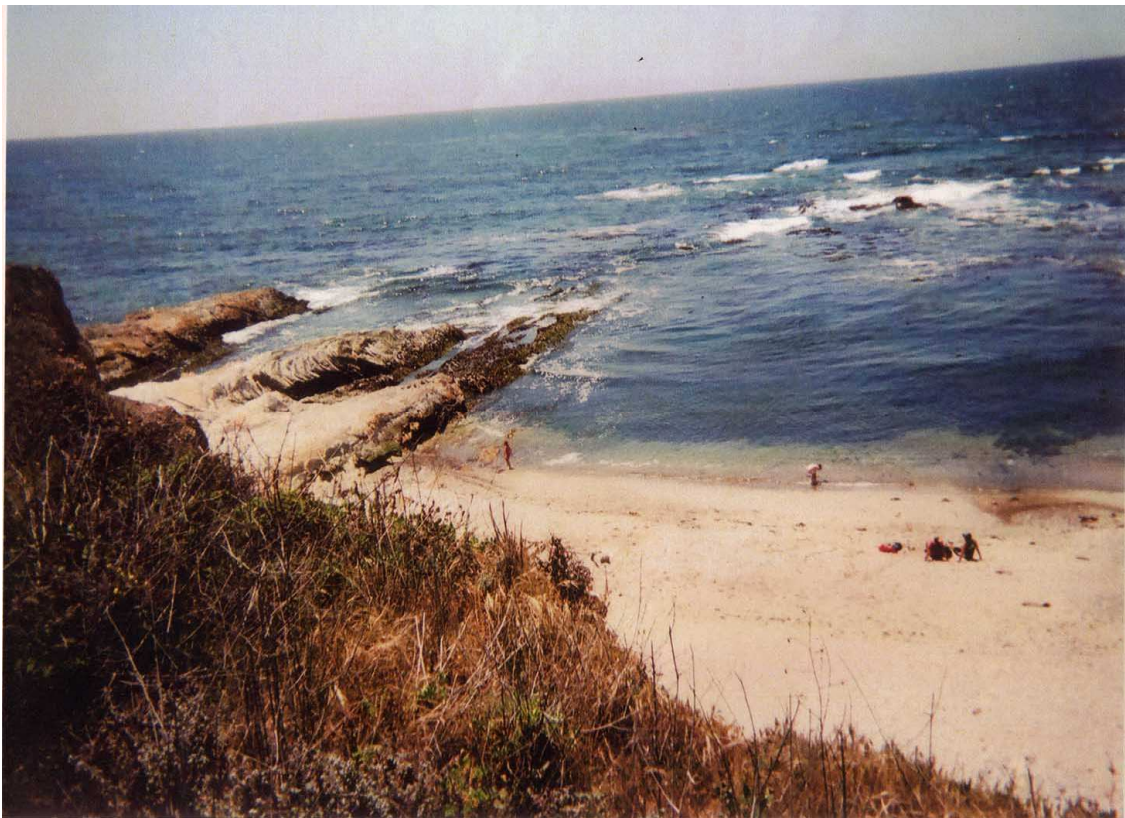
**Figure -28 South side of cove at Montana De Oro showing tilted sedimentary strata facing north.**

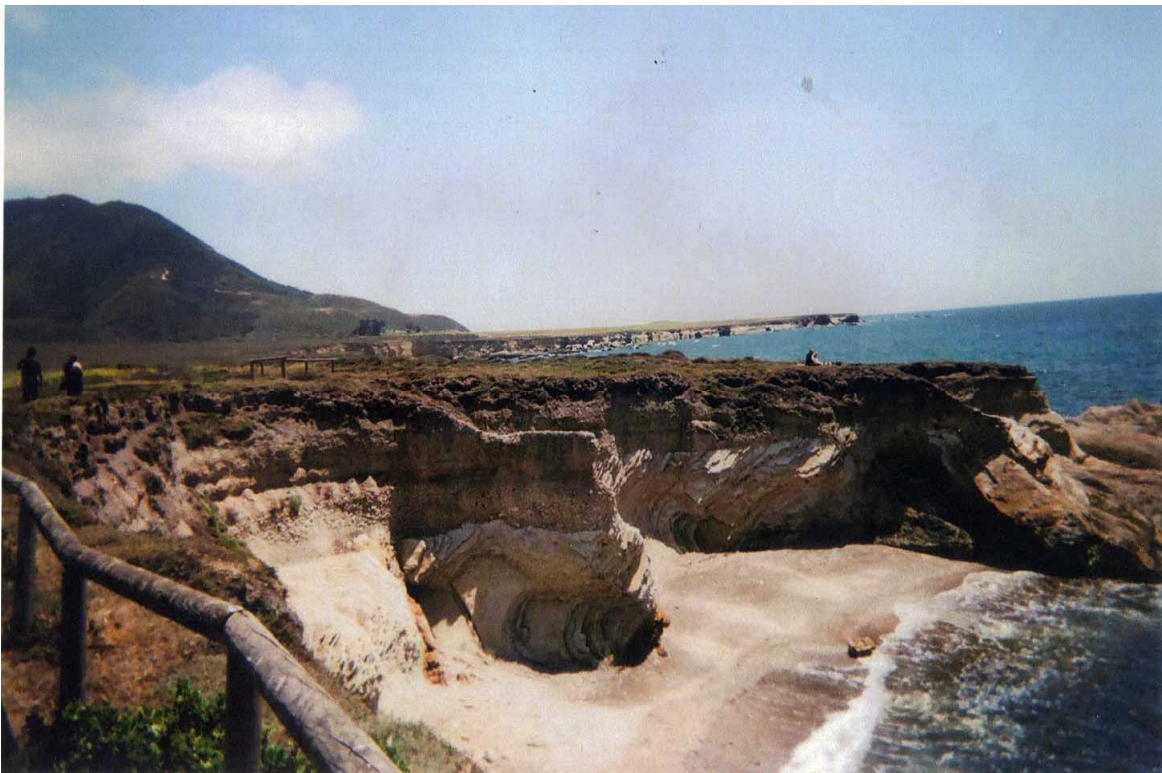
In Figure -29, left of center where the darkened mountain descends, is the Diablo facility.

**Figure -29 Closer view of sedimentary strata south of the cove. Headland (center left) is location of Diablo facility.**
